Quantitative Investigation of Surface and Subsurface Fatigue Cracks Near Rivets in Riveted Joints Using Acoustic, Electron and Optical Microscopy

**Quantitative Investigation of Surface and Subsurface Fatigue Cracks Near Rivets in
Riveted Joints Using Acoustic, Electron and Optical Microscopy**

A DISSERTATION

DOCTOR OF PHILOSOPHY

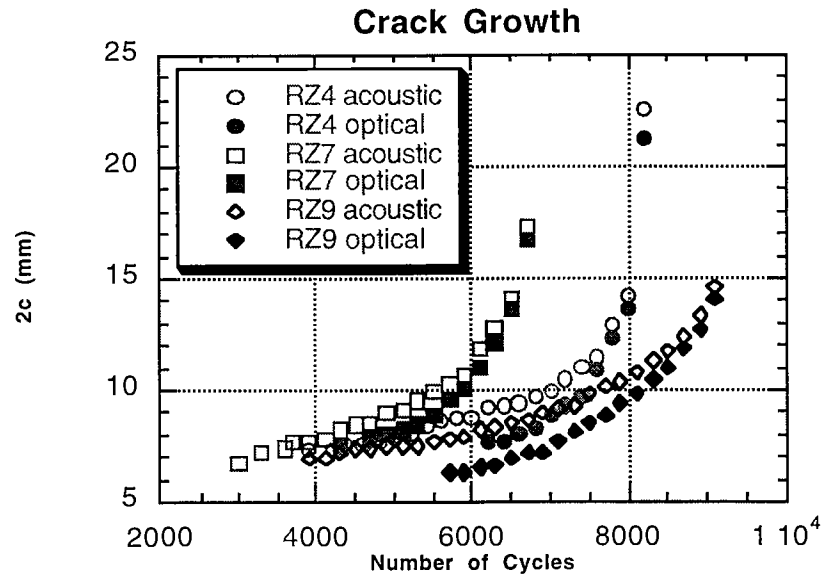
Maximum Stress of 154 MPa

Fig. 5.14. Plot of the crack growth of specimens fatigued at a maximum stress of 154 MPa as measured with the optical microscope and with the SAM. The open symbols are SAM measurements.

As detailed in Chapter 4, the crack path is much different at 154 MPa than the crack path at 103 MPa maximum nominal stress, radial vs. eyebrow cracks. Figure 5.14 is a plot of the crack growth of specimens fatigued at a maximum stress of 154 MPa as measured with the optical microscope and with the SAM. As with the cracks formed at 103 MPa, the length of the crack on the back surface of the countersunk panel remains longer than the length of the crack on the front surface of the specimen even when $2c$ is 20+ mm. This may be due to the tensile bending moment on the back surface. Also, as was the case with the cracks formed at 103 MPa, the crack growth rate increases rapidly when the crack breaks through the outer surface so that it may be seen optically. Of course, the number of cycles is much smaller for the higher stress range as well as the number of cycles to reach a 15 mm crack length. The average number of cycles for a 15 mm crack to form at the lower stress is about 240,000 cycles while the average number of cycles at the higher stress is about 8,000 cycles.

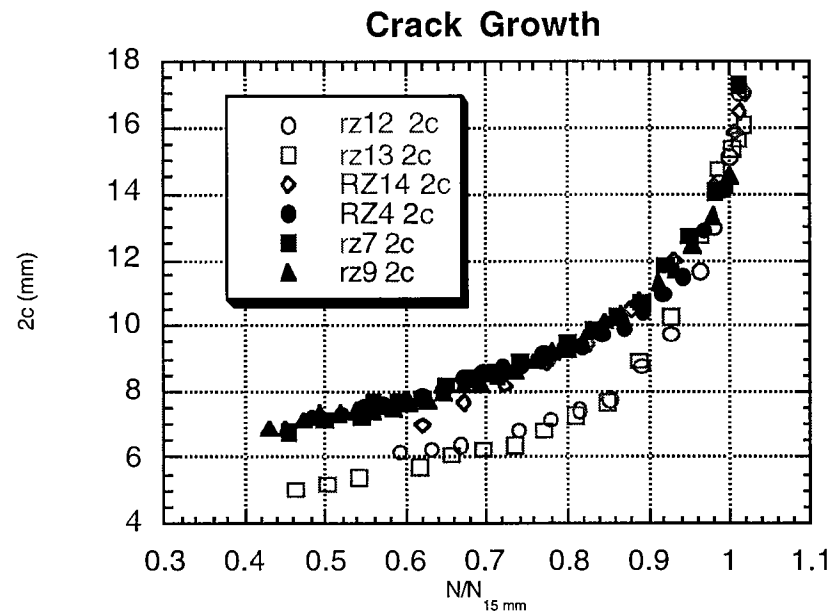
The cracks have been normalized so they are coincidental when $N = N_{15 \text{ mm}}$.

open markers: 103 MPa
filled markers: 154 MPa

Fig. 5.15. Crack lengths compared on a normalized basis, N/N_{15} . The open markers and the x represent specimens fatigued at 103 MPa and the closed markers represent specimens fatigued at 154 MPa. Crack length measurements were taken with the scanning acoustic microscope.

The $2c$ crack lengths measured by SAM for 103 and 154 MPa nominal stress are compared on a normalized basis, N/N_{15} , in Figure 5.15. N_{15} is defined here as the number of cycles for a crack to reach a length of 15 mm. Cracks on both sides of the rivet were not detected by the SAM for both nominal stress ranges until about 45% of the N_{15} . The $2c$ lengths are about 5 and 7 mm for the first data points plotted. The “eyebrow” type cracks observed at lower stresses are detected at a shorter length, because they do not form at the diameter of the rivet but rather closer to the bottom

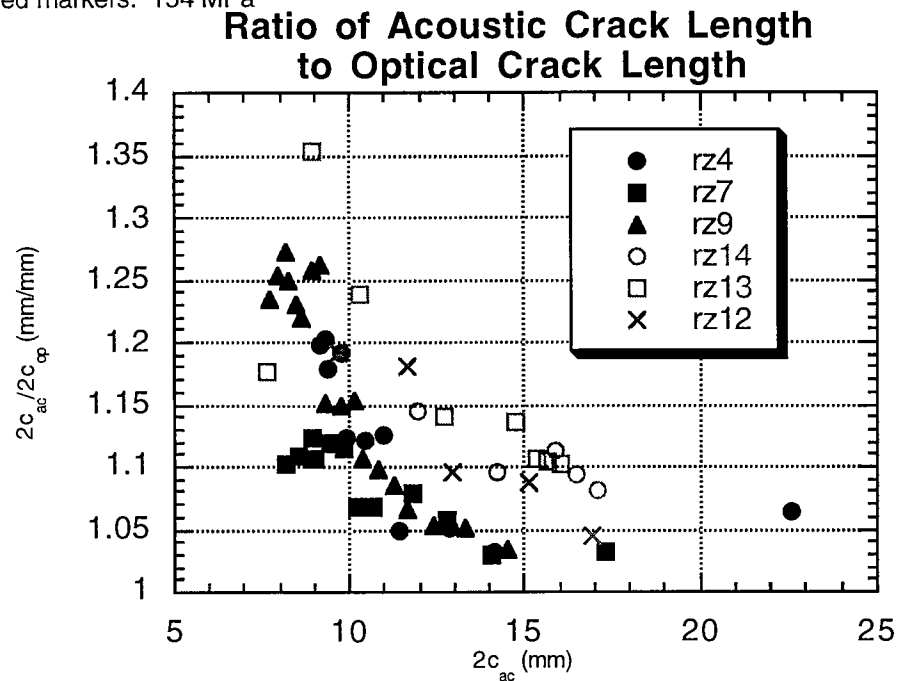
open markers: 103 MPa
filled markers: 154 MPa

Fig. 5.16. Comparison of optical and acoustic measurements. The open markers represent specimens fatigued at 103 MPa and the closed markers represent specimens fatigued at 154 MPa.

When the cracks were observed on the outer (chamfered) surface, their lengths were measured optically. The optical and SAM measurements are compared in Figure 5.16 where $2c_{ac}/2c_{op}$ is plotted against $2c_{ac}$. The SAM measures the maximum crack length, which is always longer than the length of the same crack on the outside surface at least up to the lengths measured. This ratio decreases more rapidly at the higher stress to what appears to be a steady state value with crack length. A fingernail shaped through thickness crack front is normally observed with fatigue in panel specimens subjected to mode I loading. This is due to the different stress state at the surface than in the interior. At the lower load, the ratio is still decreasing when $2c_{ac}$ is 15 mm. The first data points plotted are at about 8 mm crack length; i.e. the crack is already 8 mm long subsurface before it is seen on the surface using an optical microscope. The ratio of $2c_{ac}/2c_{op}$ decreases from about 1.3 when cracks were first noted optically to about 1.05 when the cracks are 15 mm long. These findings are of considerable importance for assessing the extent of cracking at rivets by visual examination.

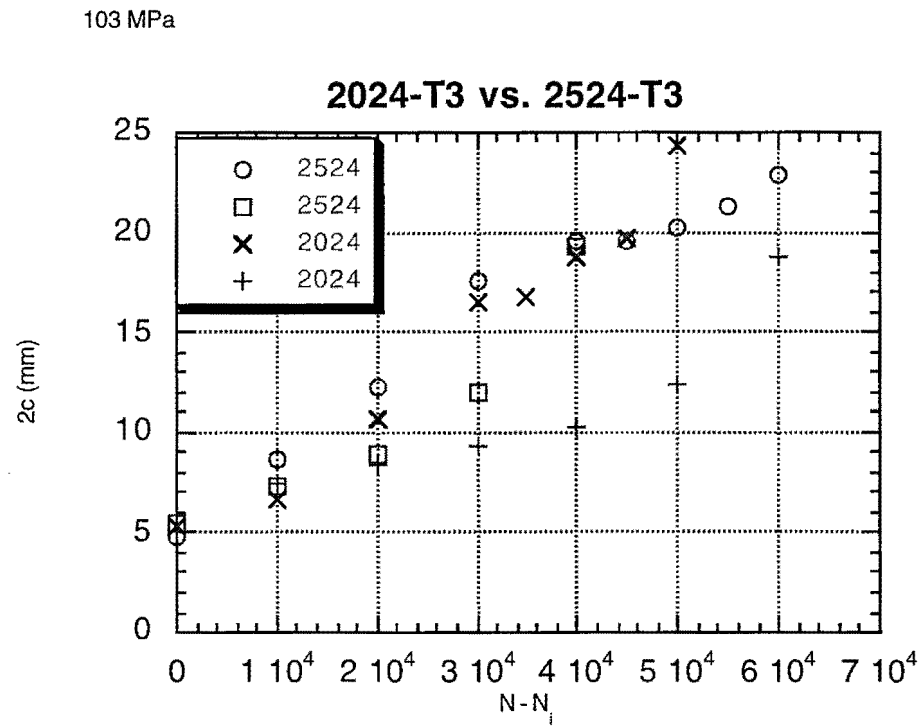
Fig. 5.17. Plot of crack growth as a function of $2c$ vs. $N - N_i$ where N_i is the number of cycles until a crack was seen on the surface for specimens fatigued at a maximum nominal stress of 103 MPa.

At both high and low stresses, there is not much difference in the crack propagation rates between the alloys after the cracks have reached the surface. This is shown in Figures 5.17 and 5.18, where N_I is the number of cycles until a crack was seen on the surface. However, at low stress, 103 MPa nominal stress, which is comparable to those experienced by aircraft skins, Alclad 2524-T3 undergoes many more cycles to surface crack appearance than Alclad 2024-T3. Thus the initiation and microcrack stages in the fatigue process are longer for the Alclad 2524-T3. As mentioned in Chapter 4, Section 4.3, this is expected since there are fewer inclusions in the 2524-T3 and so there are less fatigue crack initiation sites. At high stress, crack initiation (nucleation plus microcrack growth and coalescence) plays less of a role and the 2024-T3 has a longer life. Experiments performed by Filler (1981) on 7xxx series ultrahigh purity and commercial grade alloys displayed the long crack ΔK_0 for the high purity alloys to be about 1.9 on average and for the commercial grade alloy to be 2.4. From this it was concluded that the deformation in the commercial grade alloy at low ΔK was more evenly distributed due to dislocation bypass of the constituent particles (inclusions). This may be the origin of the reversal in behavior between low and high stress.

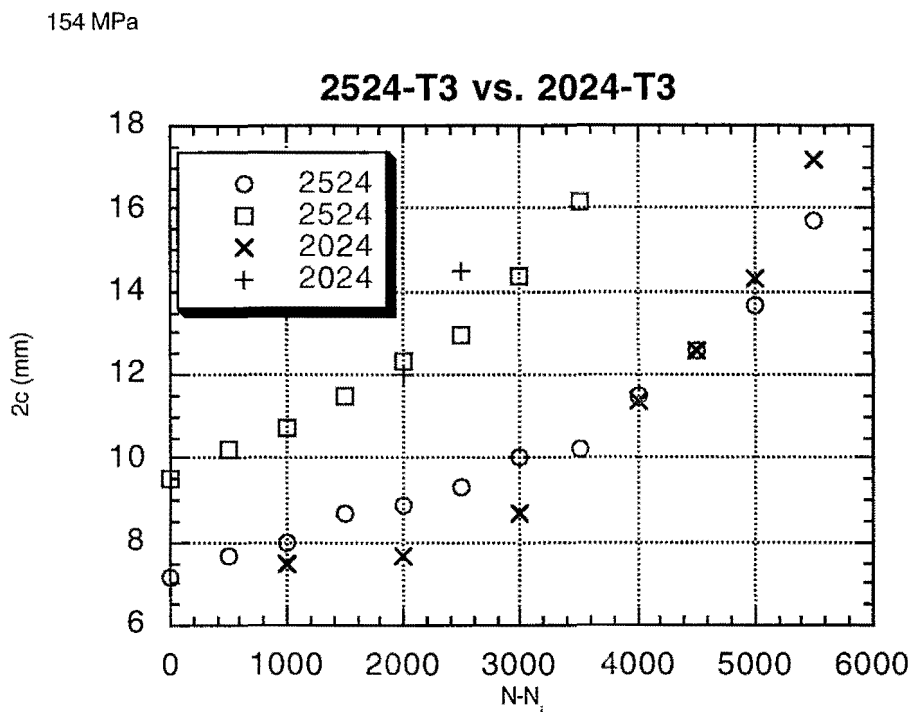
Fig. 5.18. Plot of crack growth as a function of $2c$ vs. $N - N_1$ where N_1 is the number of cycles until a crack was seen on the surface for specimens fatigued at a maximum nominal stress of 154 MPa.

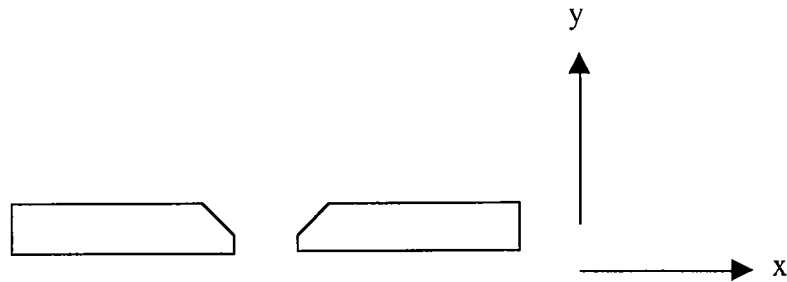
Fig. 6.1. Sketch showing x direction (growth along free surface) and y direction (growth in the constrained direction).

4. At both high and low stresses, the cracks are longer on the fayed surface of the panel than elsewhere and this difference could be due to one of three things or a combination of these. First, the bending moment results in the fayed surface being in tension and the opposite side being in compression. Secondly, it is easier for the crack to grow along the free surface in the x direction than it is for it to grow in the

constrained y direction as shown in the sketch in Figure 6.1. This would apply only until the crack broke the front surface. Thirdly, the preferred orientation of the grains enables the slip band cracks to extend across grains due to the adjacent grains having slip planes with nearly equivalent orientations. The x direction is the longitudinal (L) direction with respect to the orientation of the grains and the y direction is the short transverse (ST) direction with respect to the orientation of the grains.

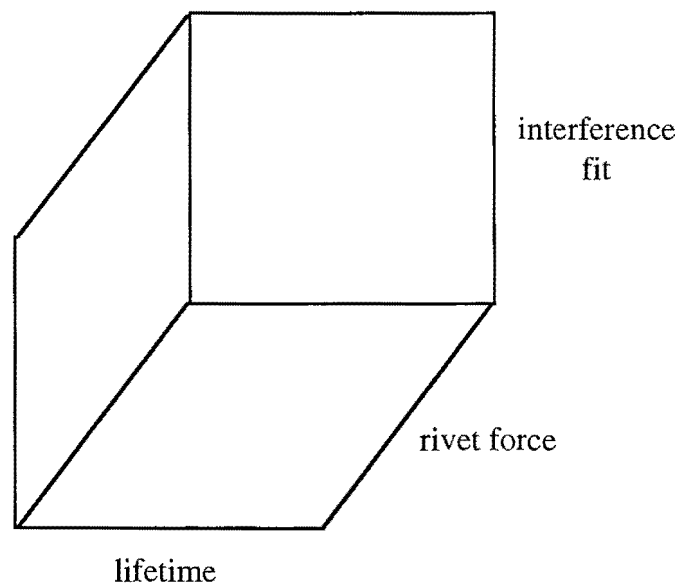
Fig. 6.2. 3-D Diagram showing the effects of various amounts of riveting force and various amounts of interference fit.

It has been shown that several factors, such as amount of interference fit, level of stress and riveting force, will affect the lifetime of the riveted lap joint. [Muller, 1995; Connor et al., 1998;] A 3-D diagram as shown in Figure 6.2 showing the effect of various amounts of interference and various amounts of riveting force on the lifetime of the joint should reveal an optimum condition for rivet force and interference fit.
